Central Purchasing Declaration of State of Emergency

EC No.: 7081

Project No.: 201900289

Date of Emergency: 12/18/2019

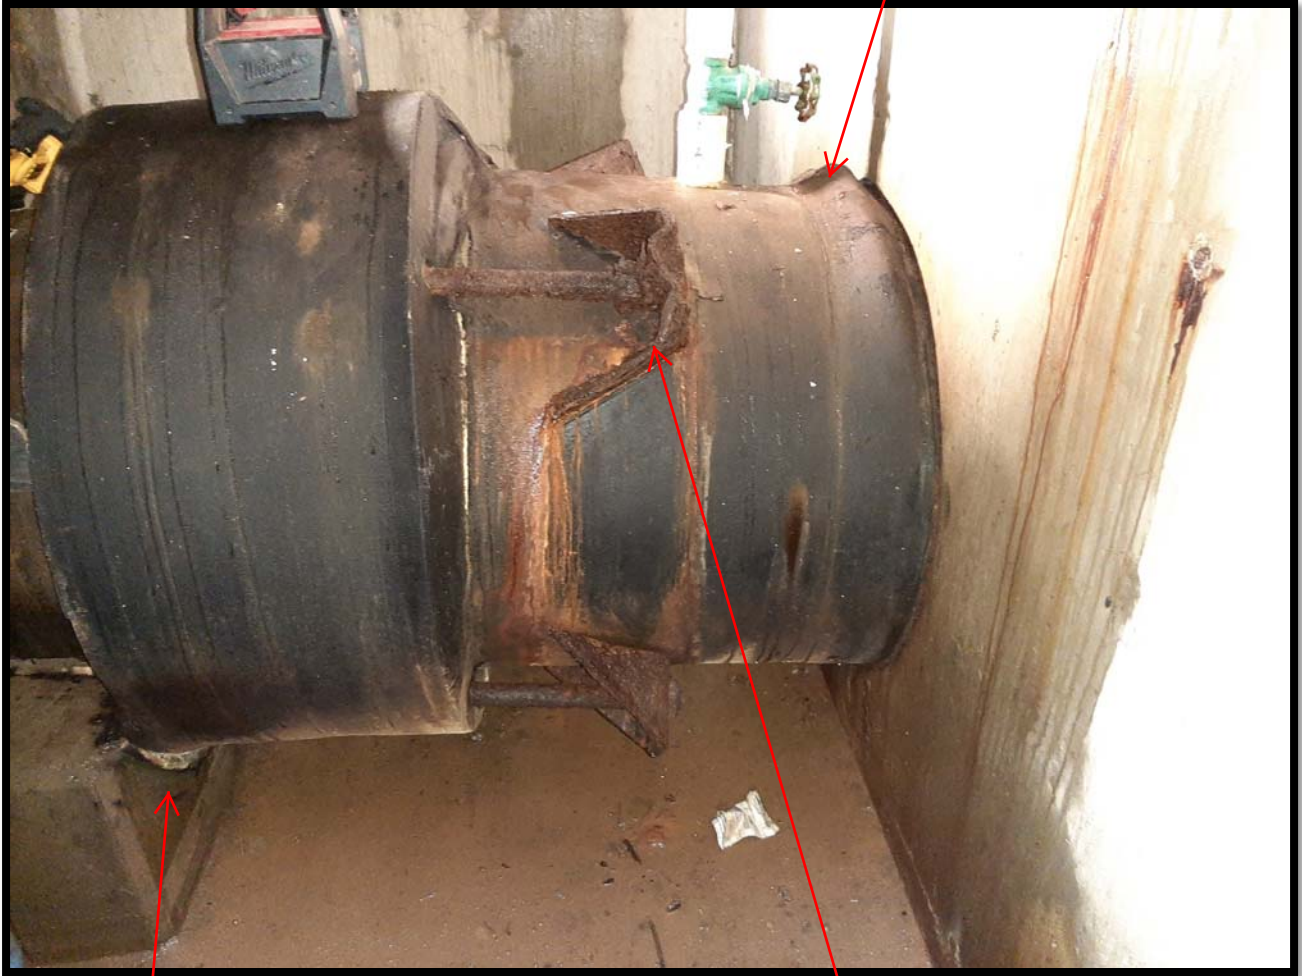
Picture 1
North Venturi

On December 16, 2019 a Pump Mechanic was investigating a high-water alarm at the northern venturi chamber at Ball Pump Station. While he was in the chamber, he noticed that the piping in the chamber is out of alignment. The venturi is currently lifted off its concrete support and the piping at the eastern end of the chamber is bearing on the chamber wall. For the venturi to be lifted off its concrete support, the discharge header outside of the chamber had to move downward. Figure 1 shows the piping layout in the vicinity of the venturi chamber. The current condition of the northern venturi is shown in Picture 1. The central venturi is also displaced, but to a lesser extent. The southern venturi did not show signs of displacement.

Insulation is pushed forward.

Venturi lifted off of concrete support.

Restraint is deformed.

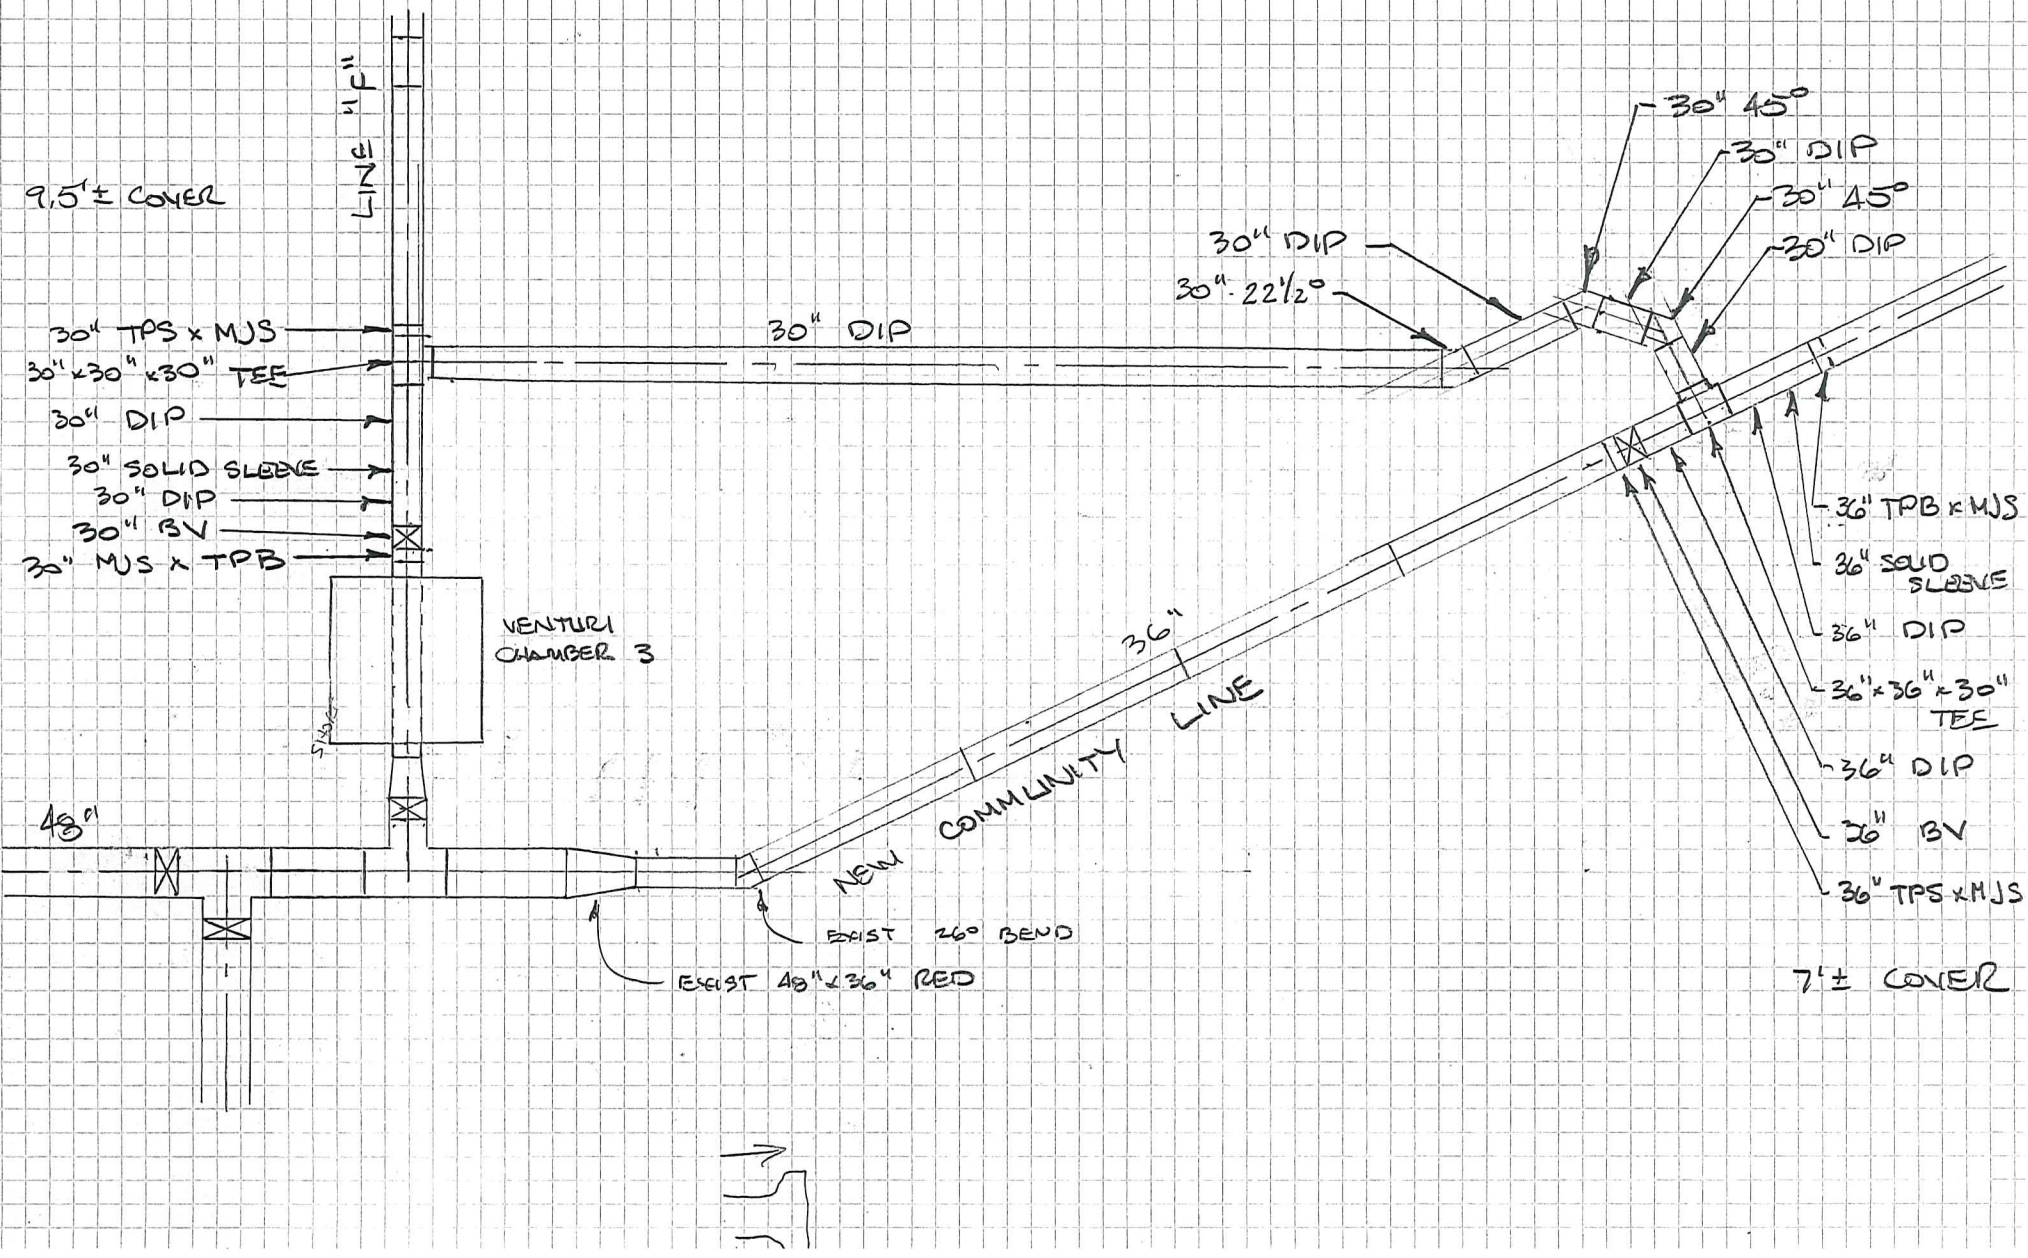
Northern Bypass Piping

Ball Pump Station is a critical pump station for delivering water to our northern service area and we need to ensure that the station stays in service. The Engineering Department is moving forward with installing bypass piping on the northern and southern sides of the station. The bypass piping will allow ECWA to keep the plant operational if there is a failure on the eastern side the discharge piping. The proposed work is depicted in Sketch 1 and Sketch 2.
