ERIE COUNTY WATER AUTHORITY INTEROFFICE MEMORANDUM

DATE: JANUARY 30, 2026

SUBJECT: Analysis of Galvanized Pipe Downstream of Lead Service Lines in ECWA the Service Area

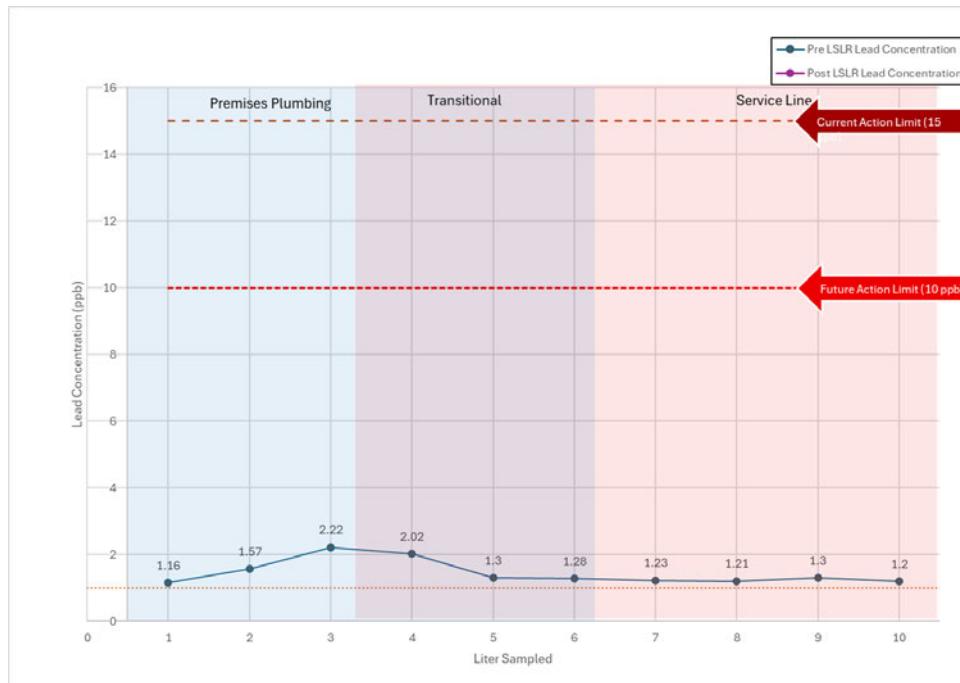
Figure 1: MEASURED LEAD RELEASE PROFILE FOR xxx ST.

For both sites there is a decrease in overall lead release for all ten liters sampled, with all of Figure 1's address' samples post-LSLR falling below detection limits for lead. For Figure 2's address, it is a similar story, but there appears to be a consistent lead release in both pre- and post- LSLR samples on the second liter. This may be attributed to an unknown lead source present within the premises plumbing.

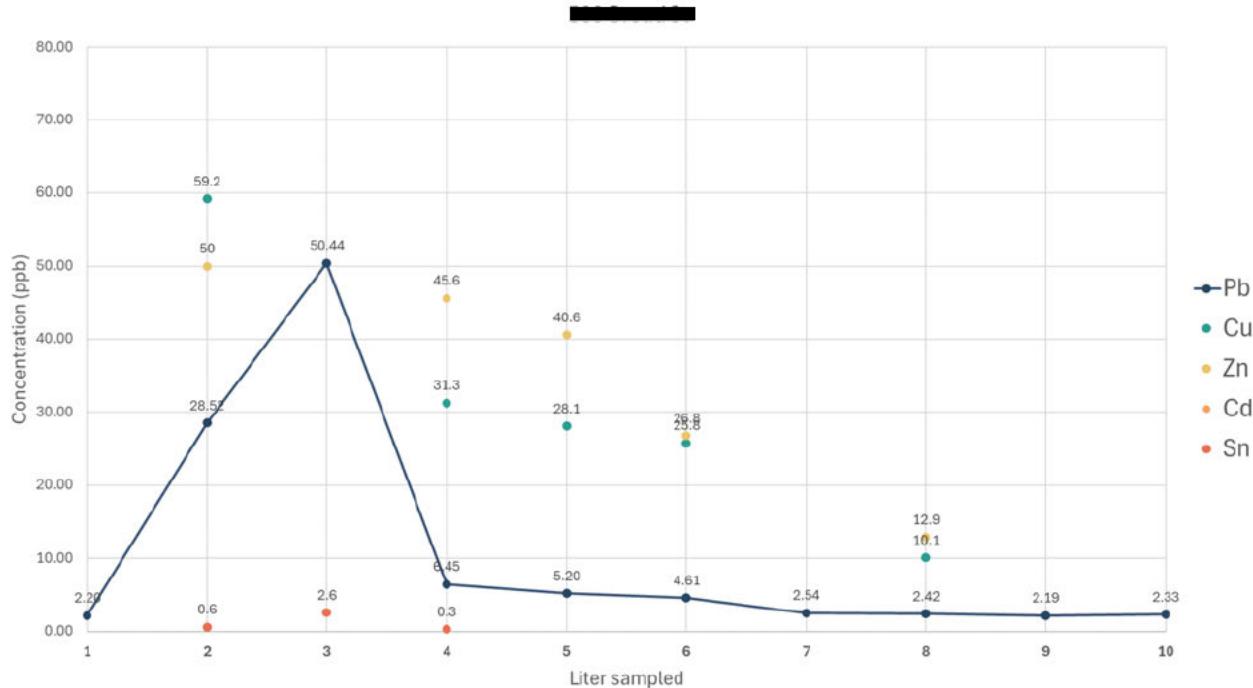
Figure 3: ELEMENTAL FINGERPRINTING FOR xxx STREET

The large release of lead (50 ppb) in the third Liter from this site from xxx Street are correlated with a large spike in release of both Copper and Zinc (391 ppb and 694 ppb, respectively, for the 3rd Liter). This indicates through elemental fingerprinting that the premises plumbing includes some form of leaded brass fixture contributing to the extreme lead release. While this capability has not been extensively used, it remains an important capability for expanding both consumers' and utilities' knowledge base.
