Central Purchasing Declaration of State of Emergency

EC No.: 7081

Project No.: 201900289

Date of Emergency: 12/18/2019

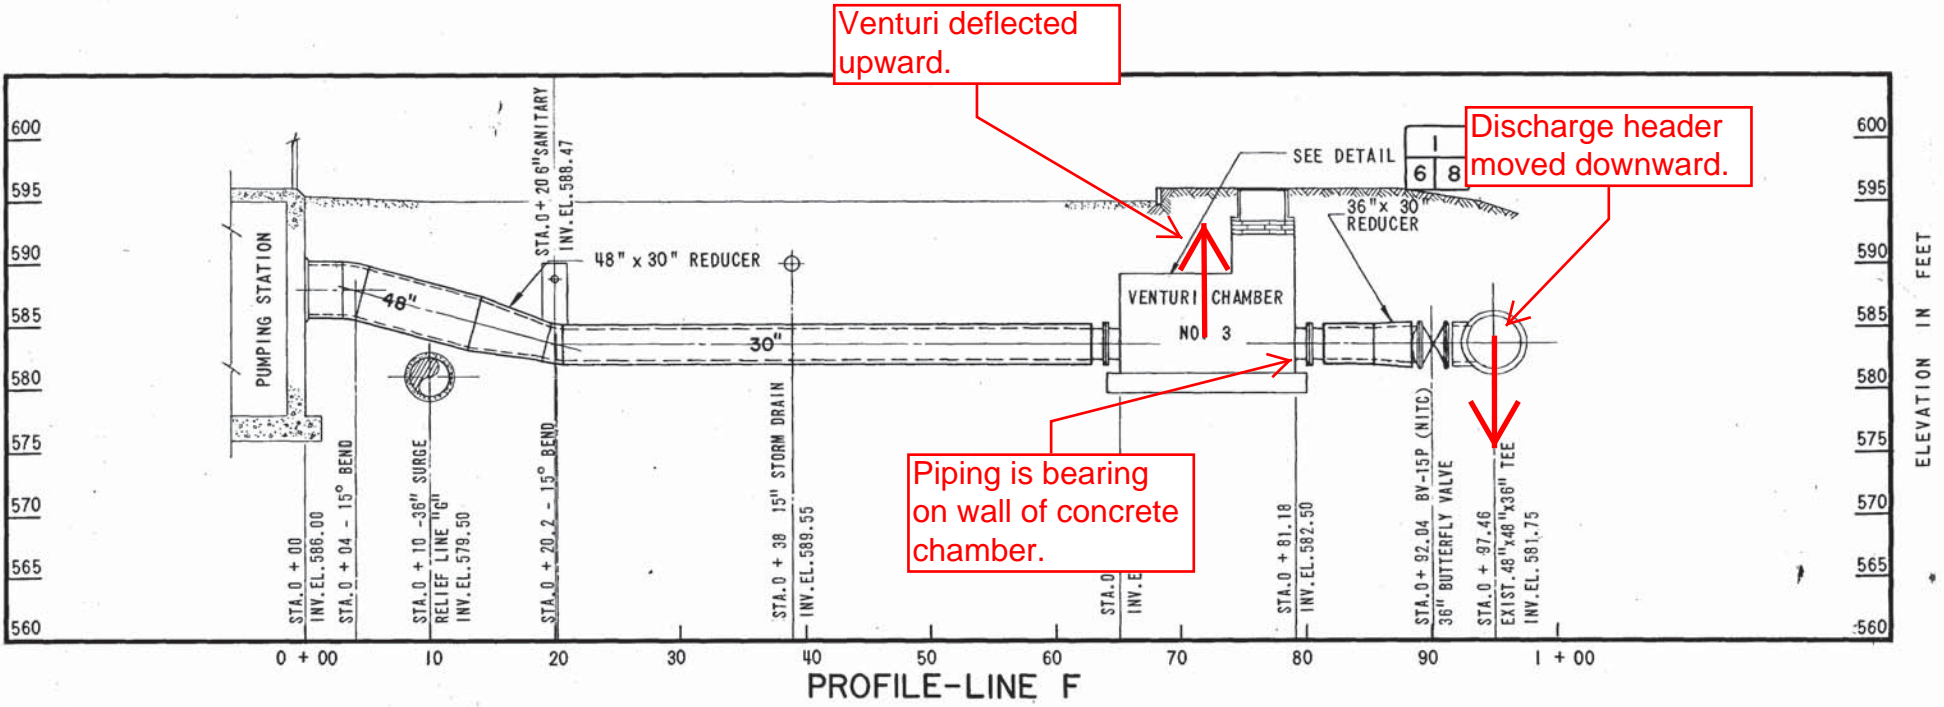
On December 16, 2019 a Pump Mechanic was investigating a high-water alarm at the northern venturi chamber at Ball Pump Station. While he was in the chamber, he noticed that the piping in the chamber is out of alignment. The venturi is currently lifted off its concrete support and the piping at the eastern end of the chamber is bearing on the chamber wall. For the venturi to be lifted off its concrete support, the discharge header outside of the chamber had to move downward. Figure 1 shows the piping layout in the vicinity of the venturi chamber. The current condition of the northern venturi is shown in Picture 1. The central venturi is also displaced, but to a lesser extent. The southern venturi did not show signs of displacement.

Ball Pump Station is a critical pump station for delivering water to our northern service area and we need to ensure that the station stays in service. The Engineering Department is moving forward with installing bypass piping on the northern and southern sides of the station. The bypass piping will allow ECWA to keep the plant operational if there is a failure on the eastern side the discharge piping. The proposed work is depicted in Sketch 1 and Sketch 2.
